Manhole Inspection Summary

Manhole # S35C__054MH

Insp Date: **8/10/09 10:16 PM**

Location Address: **St Paul PI**

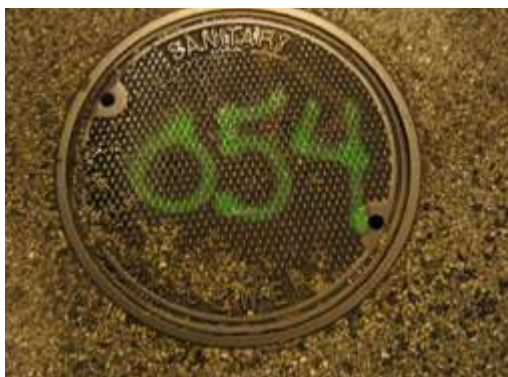
Miscellaneous

mh cover

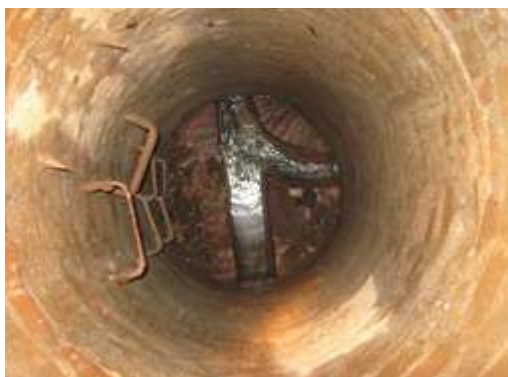
Defect 2

Infiltration: ☐ None ☐ Joint ☐ Cracks ☐ Mortar ☐ Roots ☒ **Wall**

Missing: **1**

☒ **Corroded**

Missing/corroded steps; signs of infiltration on barrel walls

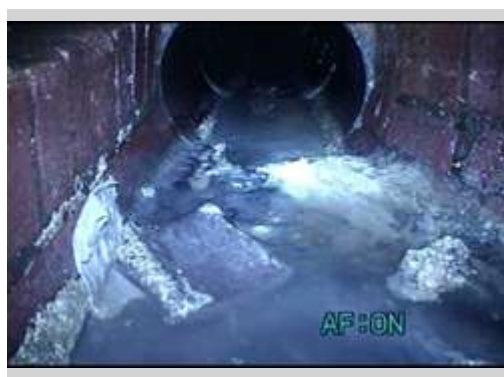
Defect 1

Condition: ☐ Sound ☐ Cracked ☐ Root Intrusion ☐ Deteriorated ☐ Leaks ☒ **Debris**

debris in channel - piece of pipe

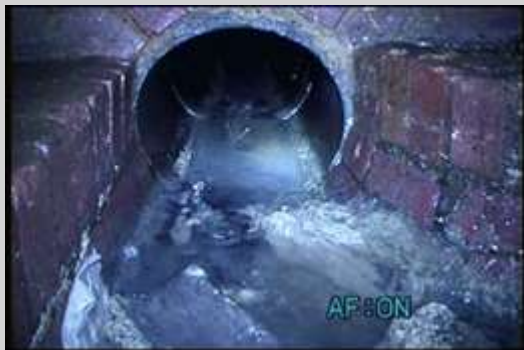
12 O'Clock Outflow

Pipe Height: **10.8** (in.) Rod and Bar (Angled)
Pipe Material: **Clay** ☐ Pipe Lined
Invert Depth: **13.50** (ft.) Flow Characteristics: **Fast**
Deposits: ☒ None ☐ Mud ☐ Sludge ☐ Debris ☐ Grease
Silt Depth: **0** (in.) Deposits Extent:
Infiltration: **None** Pipe Seal Cond: **Sound**

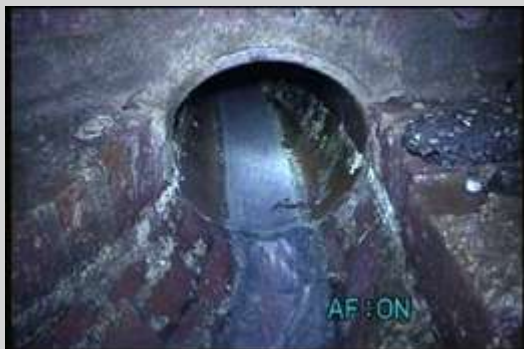
3 O'Clock Inflow

Pipe Height: **10.8** (in.) Rod and Bar (Angled)
Pipe Material: **Clay** ☐ Pipe Lined
Invert Depth: **13.20** (ft.) Flow Characteristics: **Fast**
Deposits: ☒ None ☐ Mud ☐ Sludge ☐ Debris ☐ Grease
Silt Depth: **0** (in.) Deposits Extent:
Infiltration: **None** Pipe Seal Cond: **Sound**

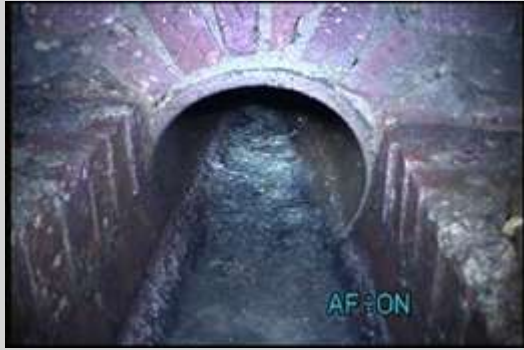
6 O'Clock Inflow

Pipe Height: **10.8** (in.) Rod and Bar (Angled)

Deposits: ☒ None ☐ Mud ☐ Sludge ☐ Debris ☐ Grease

Infiltration: **None** Pipe Seal Cond: **Sound**
